A Preliminary Reconnaissance Report on August 11th 2012, Varzaghan-Ahar Twin Earthquakes in NW Of Iran

Mehran S. Razzaghi

Mohsen Ghafory- Ashtiany

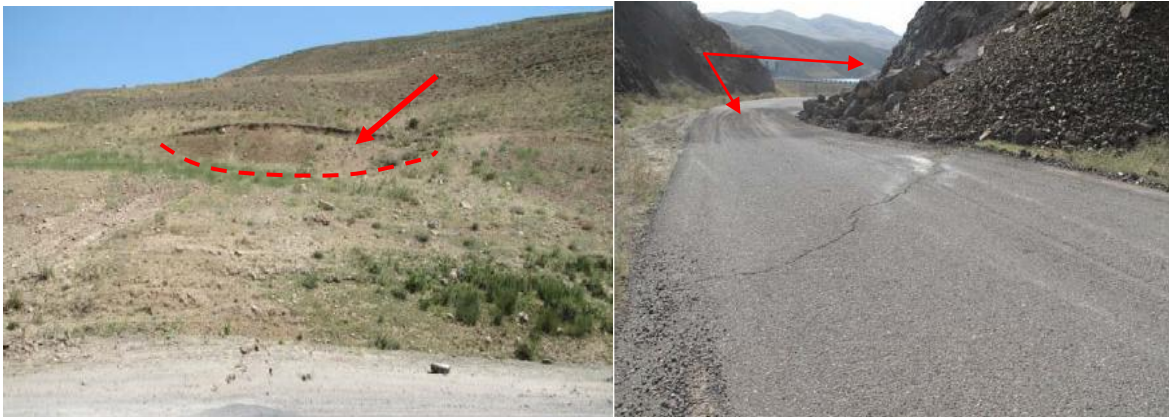
Several landslides and rock falls occurred in the stricken area, as shown in Figures 7. Most of the observed landslides and rock falls were happened next to the Khajeh- Ahar and Khajeh-Varzaghan roads. The distances of the most observed rock falls to the epicenter were less than 20 Km. No evidence of liquefaction and/or sand boiling observed in the stricken area.

Figure 7. Landslide and rock fall near Chaykandi Village [2]

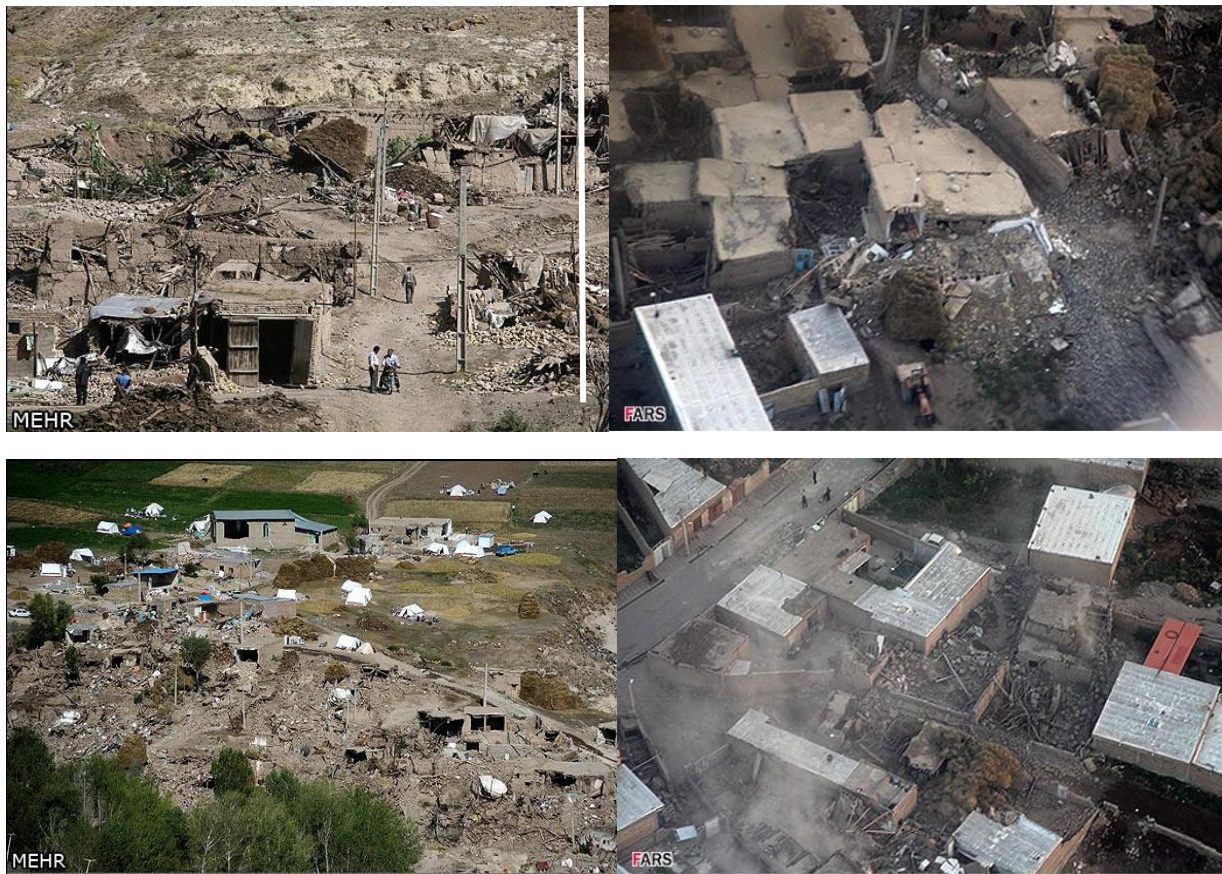
Most of the collapsed and damaged houses in the effected villages, as shown in Figure 8, were adobe and unreinforced masonry buildings. The main failure modes of these types of building are the failure of heavy roofs, in plane failure of walls and out of plane failure of walls as shown in Figure 9. In general, performance of the brick masonry buildings was noticeably better than of adobe ones. Both framed (steel and RC) structures and brick masonry buildings exist in urban areas. No observable structural damage occurred in residential buildings of the Herris city. Few nonstructural damages observed in these buildings. As shown in Figure 10 residential buildings of different types damaged in both Ahar and Varzaghan cities and villages of stricken area. Infill walls of some of the buildings cracked in northern parts of Tabriz city. It should be noted that buildings with minimum code requirements have survived the earthquake as indicated in Figure 11.

Figure 8. Overall view of the damaged area. It shows that most damages were due the collapse of adobe buildings [Fars News Agencies]

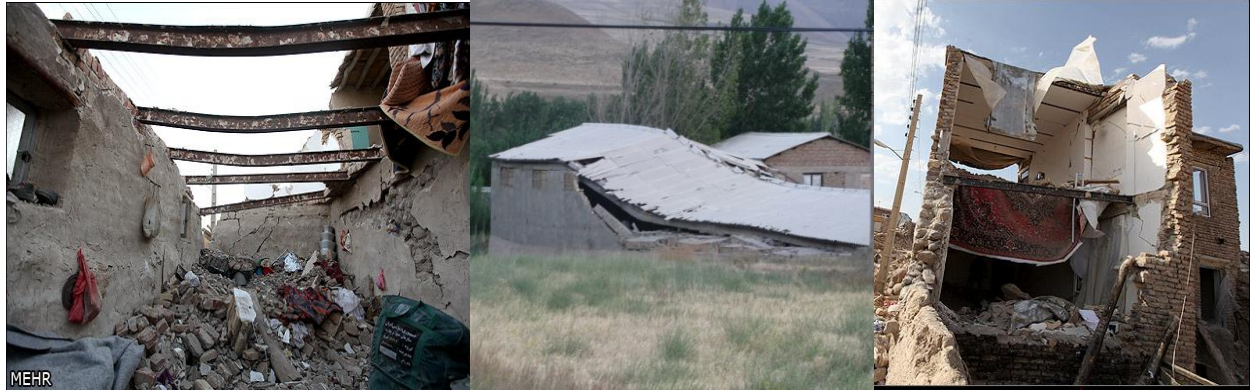
Figure 9. Failure of heavy steel jack-arch and concrete roofs, and walls of UnreinforcedMasonry buildings (Bastami and Mehr News Agency)

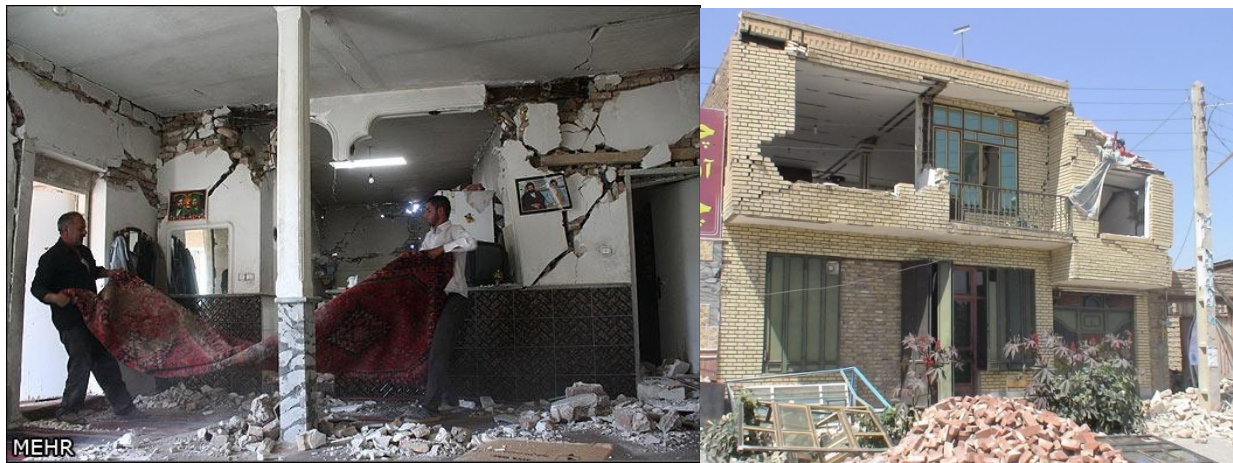
Figure 10. Performance of semi-steel frame buildings in villages (Mehr News Agency and Bastami)

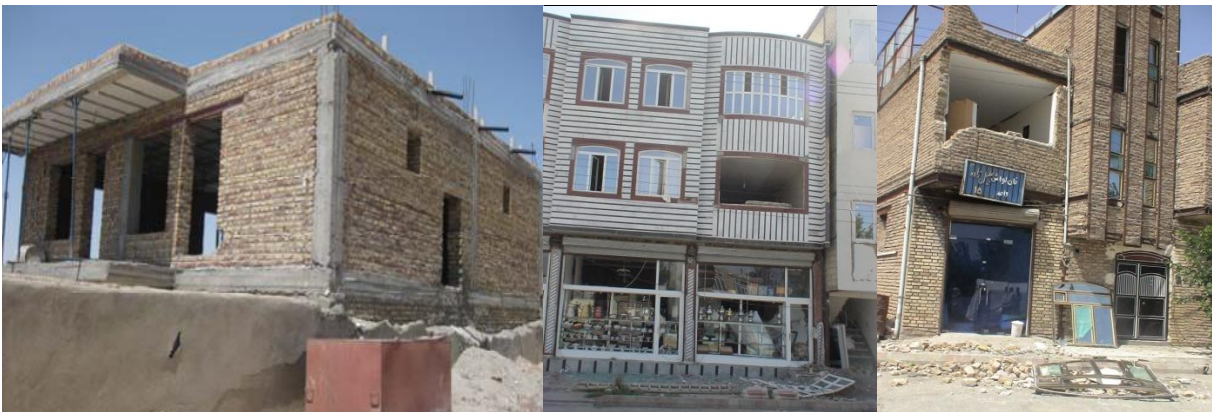
Figure 11. Buildings with minimum code requirement have survived the earthquake (Mehr News Agency; Kalantari-IIIES and Bastami-IIIES)

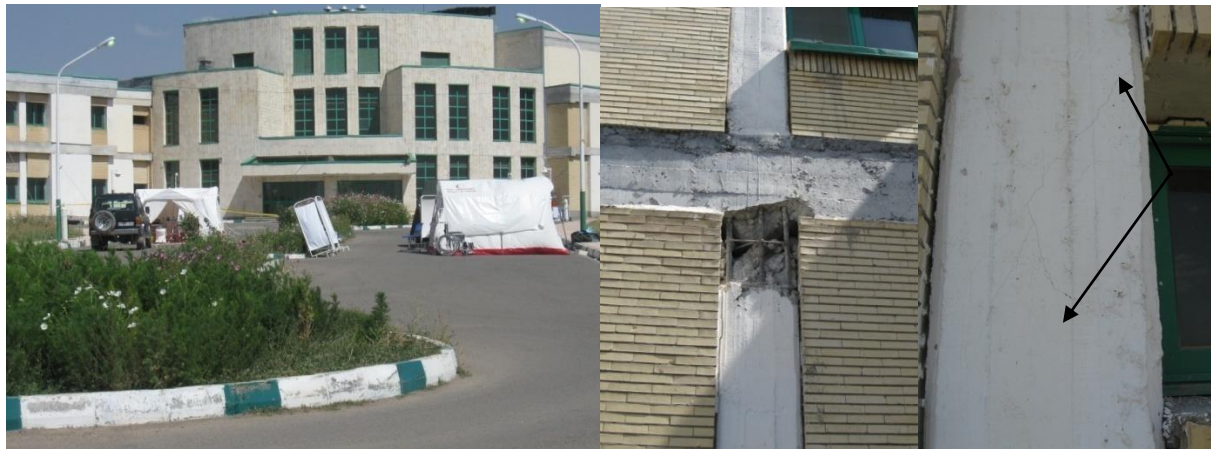
Hospitals: Performance of Hospitals was not acceptable. Main Heriss hospital with RC moment resisting frame experienced small structural damage due to occurrence of plastic hinge and failure of many columns near to beam-to-column joint, as shown in Figure 12. All of the observed plastic hinges were located in the columns of the first floor. Some of the columns experienced shear cracks next to the openings of the infill walls. In addition to the abovementioned failures, as shown in this figure, diagonal cracks observed in some of the beams net to the column joint. It seems that the main reason for unacceptable performance of the structural system was poor quality of construction and low quality of concrete. Such a performance occurred because of weakness of the cementitious matrix and/or insufficient bondage of cement paste and the aggregates. Figure 13 shows that non-structural damages on the hospital such as diagonal cracking and out of plane failure of infill walls, failure of facades and false ceilings were the major failure modes of the non-structural elements. The hospital was not operable after the earthquake. The Bagher-Al-Oloom Hospital in Ahar city also suffered remarkable nonstructural damages and put out of commission after the earthquake [2]. In plane failure of infill walls, failure of false ceilings and overturning of medical equipment were the major failure mode of non-structural components in this hospital.

Figure 12. Heriss hospital structural damage to the: Plastic hinges on beam-columns joint and diagonal crack of the column.

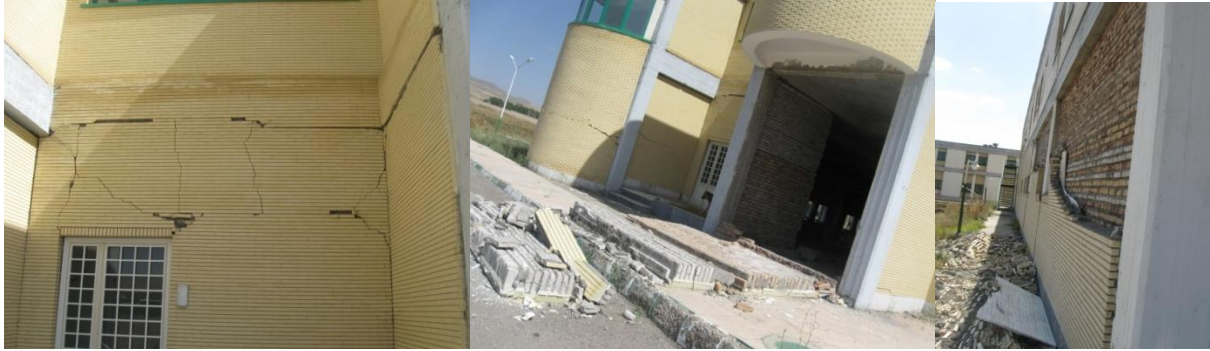
Figure 13. Nonstructural damage to Herris hospital:

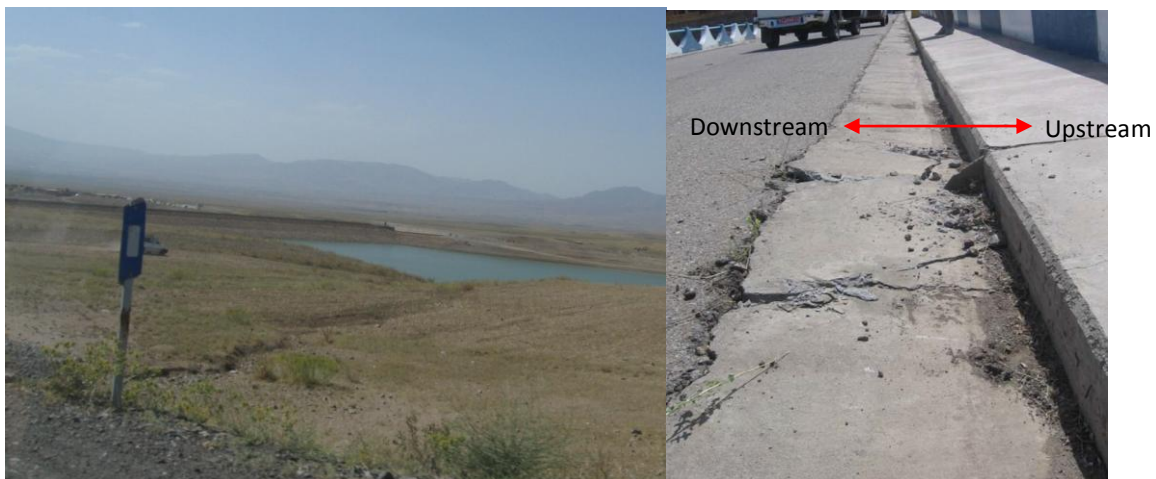
Dams: Sattarkhan and Herris embankment dam is the most important dam in the affected area, that remained operational, as shown in Figure 14. A crack parallel to upstream-downstream direction was observable in pavement of the crest of the Sattrakhan Dam [2].

Herris dam (no damage)

Sattarkhan dam (some cracks on its crest)

Figure 14. Sattarkhan and Herris embankment dam with no damage [2]

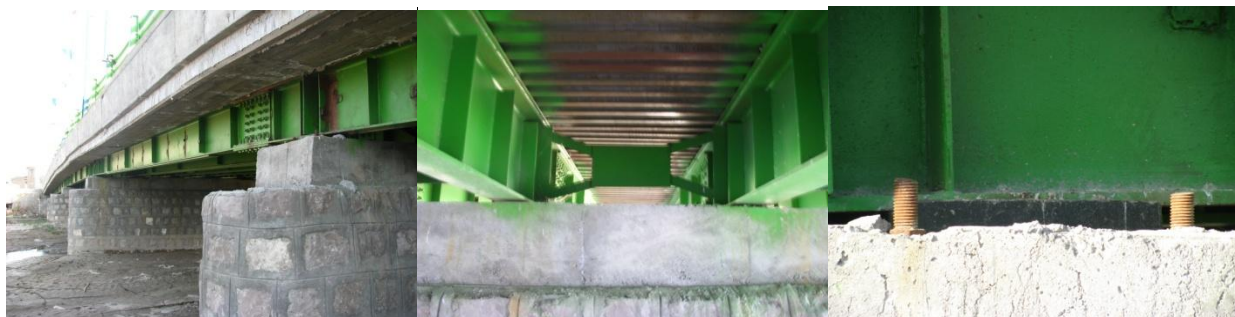
Roads and Bridges: Although some of the bridges in the affected area suffered structural damage, all of the observed bridges were fully serviceable after the earthquake. Figure 15, indicates a bridge with minor damage. The pavement of some of the roads cracked due to the fault rupture and geotechnical instabilities but the roads was serviceable after the earthquake.

Figure 15. A serviceable bridge after the earthquakes [Bastami, IIEES]
